# Manhole Inspection Summary

## Manhole # S47EE\_013MH

Insp Date: **7/17/08 11:46 AM**

**Location** Address: **Patterson Park**

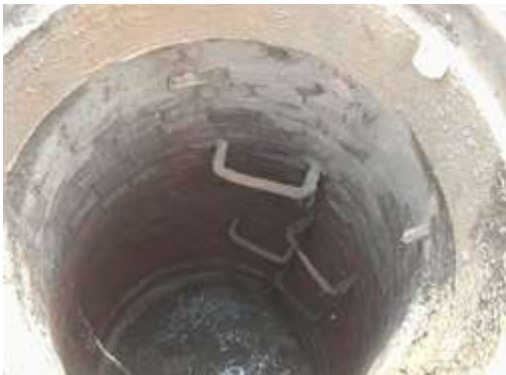
Defect 2

☒ **Leaks**

Frame Leaks

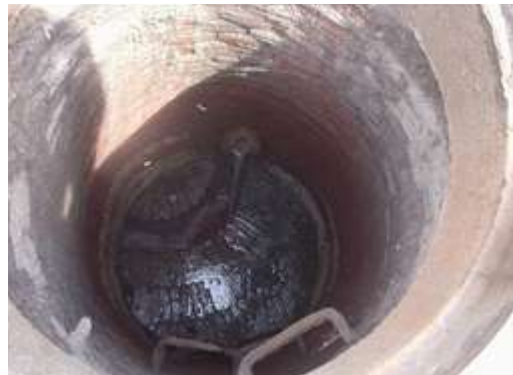
Defect 1

Infiltration: ☐ None ☐ Joint ☐ Cracks ☐ Mortar ☐ Roots ☒ **Wall**

Infiltration

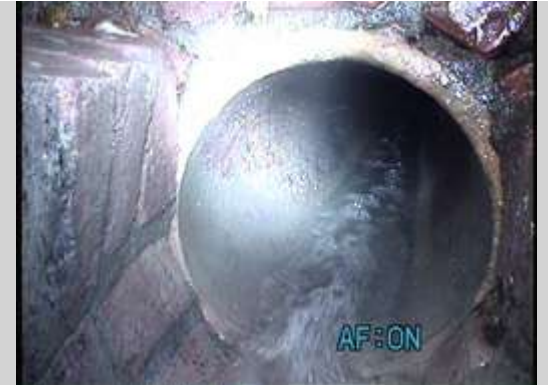
12 O'Clock Outflow

8 in. Circular Gravity Sewer  
Pipe Out @ 12 O'Clock

Pipe Height: **8.4** (in.) Rod and Bar (Angled)  
Pipe Material: **Clay** ☐ Pipe Lined  
Invert Depth: **11.60** (ft.) Flow Characteristics: **Fast**  
Deposits: ☒ None ☐ Mud ☐ Sludge ☐ Debris ☐ Grease  
Silt Depth: (in.) Deposits Extent:  
Infiltration: **None** Pipe Seal Cond: **Sound**

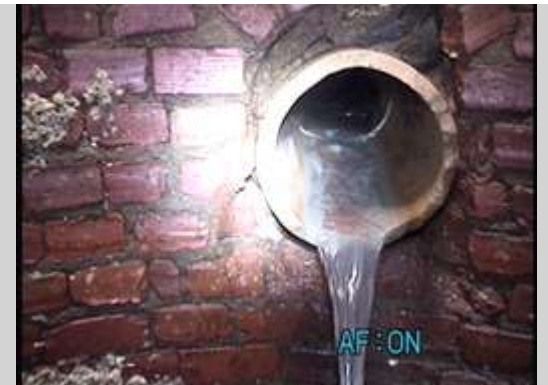
3 O'Clock Inflow

8 in. Circular Gravity Sewer  
Pipe In @ 3 O'Clock

Pipe Height: **8.4** (in.) Rod and Bar (Angled)  
Pipe Material: **Clay** ☐ Pipe Lined  
Invert Depth: **9.25** (ft.) Flow Characteristics: **Fast**  
Deposits: ☒ None ☐ Mud ☐ Sludge ☐ Debris ☐ Grease  
Silt Depth: (in.) Deposits Extent:  
Infiltration: **None** Pipe Seal Cond: **Sound**

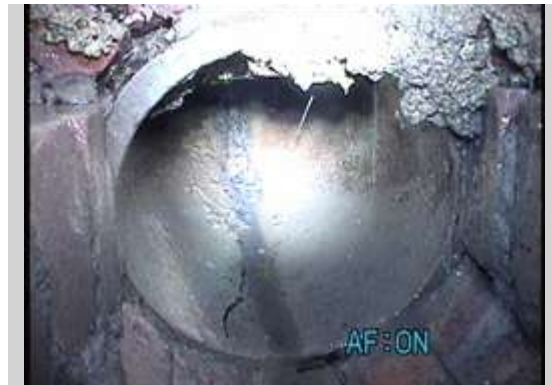
Drop In @ 3 O'Clock

Drop: **Inside** Rod and Bar  
Angled: **Yes** Reading: **10.45** (ft.)  
Inv Depth: **11.45** (ft.)  
Drop Condition: **Open**
